Conservation in Earthen Heritage:

*Assessment and Significance
of Failure, Criteria,
Conservation Theory,
and Strategies*

Mariana Correia

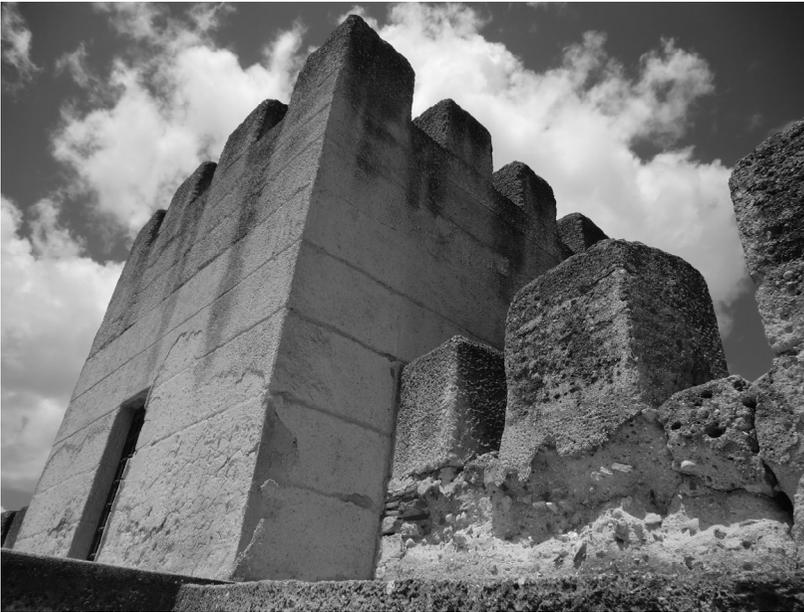
Fig. 1.1 - Failure following conservation intervention at the earthen fortress of Alcácer do Sal, Portugal (credits: Mariana Correia).
