Unconventional Aeronautical Investigatory Methods:

*The Case of Alitalia
Flight AZ 112*

Rosario Ardito Marretta

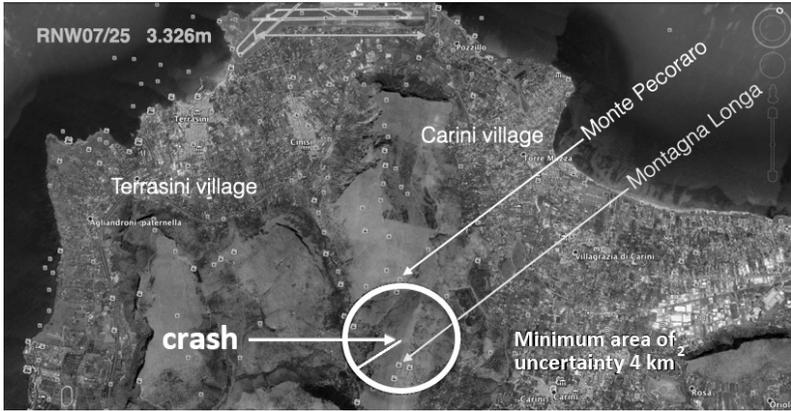
Fig. 5 Google Earth[®] view of the gulfs at Terrasini (left) and Carini (right).

Following the suggestion that the impact might have occurred around 22.24 local time can reasonably allow for a minimum period of time ranging from 22:23:59 to 22:24:59, or around 60". The speed of the AZ 112, due to its attitude, its dimensions, its weight, its configuration is, at most with flaps at 25° (reasonable assumption for the final approach speed), was 220 kts (knots),¹¹ that is, an average speed of 110 m/s. This implies that, along with the uncertain space in time of 60", a similarly uncertain path in terms of the crash site would be 6600 m.

If we look at Fig. 5 and refer to the layout of runway 07-25 at Punta Raisi, which we know is 3326 m in length, by drawing a circle with a radius subtending a circumference as long as this area of uncertainty, we find it is almost 4 km²! This begs two questions. The first: what if that uncertain time frame were greater? The second: how can we find out more about the movements of this aircraft in that unknown but very real area of uncertainty?
